Aviation Investigation Final Report

Location:	Truckee, California	Accident Number:	WPR21FA286
Date & Time:	July 26, 2021, 13:18 Local	Registration:	N605TR
Aircraft:	BOMBARDIER INC CL-600-2B16	Aircraft Damage:	Destroyed
Defining Event:	Loss of control in flight	Injuries:	6 Fatal
Flight Conducted Under:	Part 91: General aviation - Personal

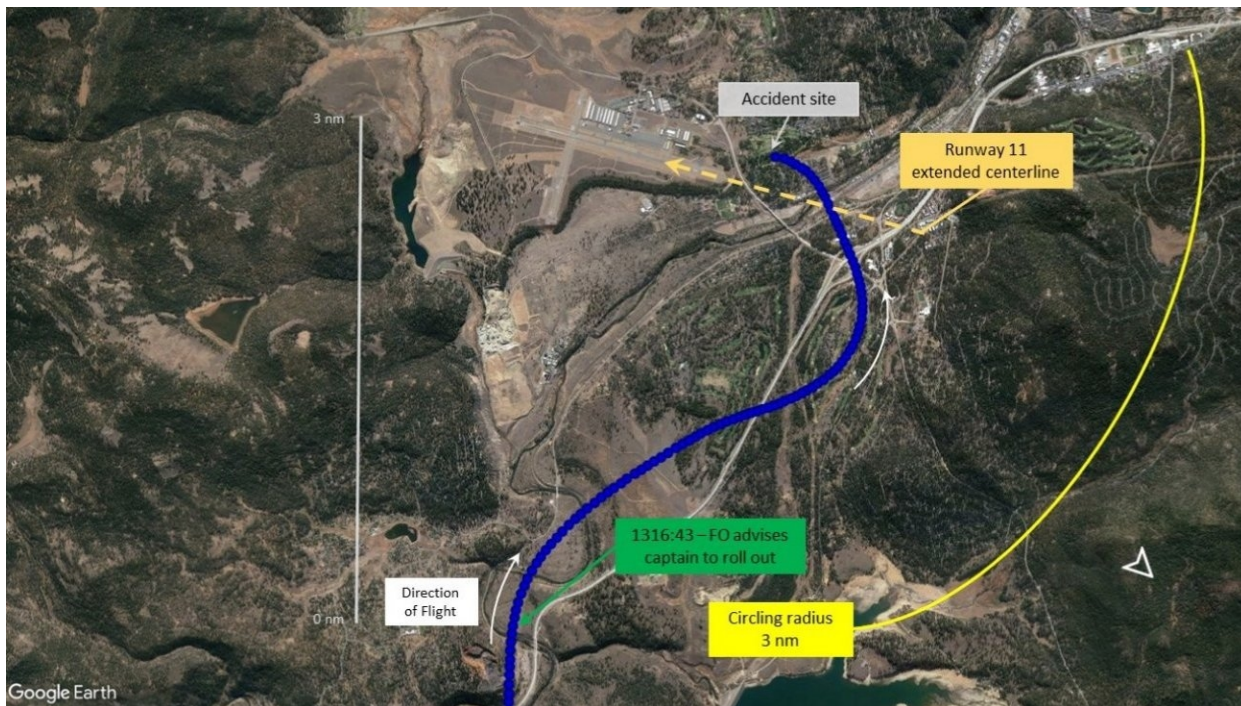
At 1316:20, the FO deployed full flaps (45°) after confirming with the captain. A second later (near YAKYU waypoint), the FO said, "There's the airport," told the captain to make a 90° right turn, and contacted Truckee tower, which cleared the airplane to land. The FO attempted to point out the airport to the captain, and the captain asked "where?" twice. At 1316:43, the FO told the captain to roll out (level the wings, stopping the turn) and turn the autopilot off. The airplane was at the beginning of the downwind leg turn (about 213° magnetic) when the FO told the captain to roll out, and the airplane rolled out on a heading of about 233°. Figure 2 depicts the turns taken by the airplane in the approach and the maximum circling radius of 3 nm allowed for category C aircraft at TRK in the airport's approach charts (the airplane was at least 1.3 nm from that maximum circling radius).

Figure 2. The airplane's downwind leg and allowed circling radius.

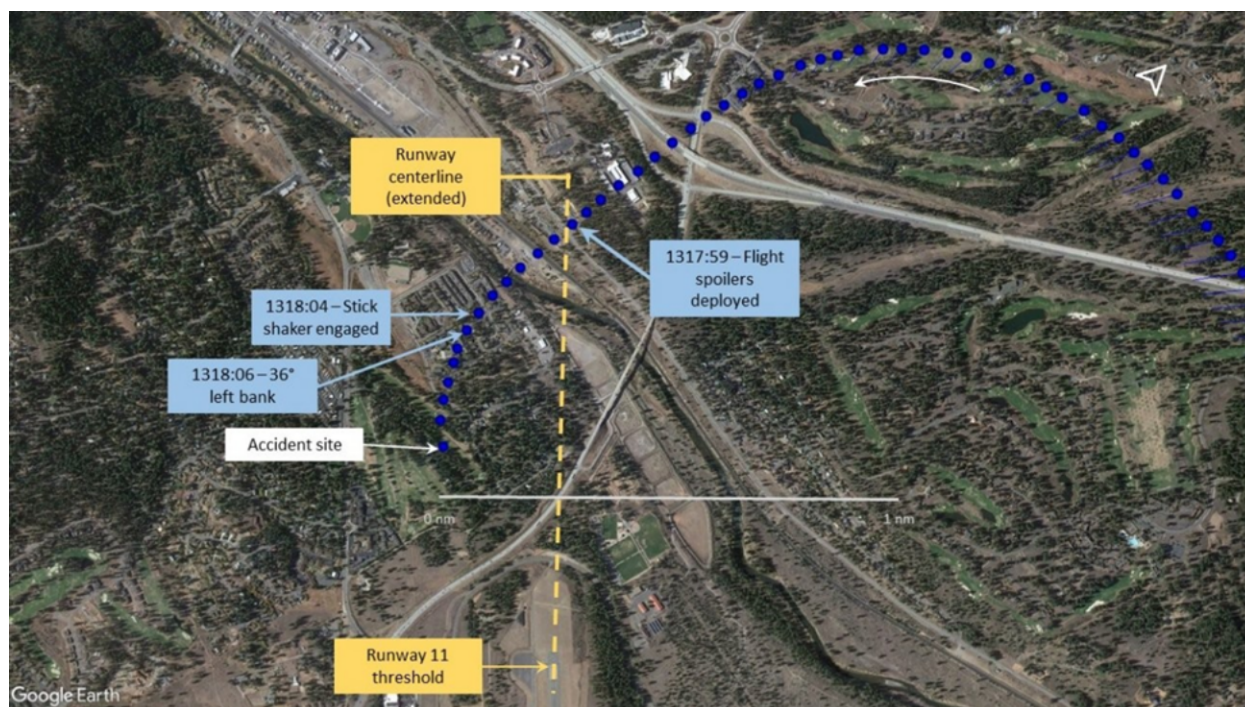
At 1317:59, the airplane began a left turn that reached a bank angle of 36° about 4 seconds later. According to the CVR data, the stick shaker engaged at 1318:04, then the captain asked, "What are you doing," which was followed by a stall warning sound. The airplane was on a south heading about 0.75 nm from the runway threshold as it continued to turn back toward the extended runway centerline (see figure 3). The stick pusher engaged about 1318:05. (For more information about the stick shaker and stick pusher, see the section below about the SPS.) The captain again asked the FO, "What are you doing?" and the FO then asked the captain three times over 2 seconds to "let me have the airplane." The stick pusher disengaged at 1318:07 followed immediately by the stick shaker disengaging. At 1318:09, the stick shaker engaged again followed immediately by the stick pusher engaging, and the airplane was about 6,075 ft msl on a southeasterly heading when it entered a rapid left roll. The airplane was in a 111° left-wing-low bank angle at 1318:11 and 1 second later it was in a 146° right-wing-low bank angle and an approximate 30° nose-low attitude, just before the airplane impacted terrain and a postcrash fire ensued.

Figure 3. Accident airplane's flightpath during final approach after crossing the runway centerline.
