Aviation Investigation Final Report

Location:	Kalea, Hawaii	Accident Number:	ANC22FA041
Date & Time:	June 8, 2022, 17:26 Local	Registration:	N402SH
Aircraft:	Bell 407	Aircraft Damage:	Substantial
Defining Event:	Part(s) separation from AC	Injuries:	3 Serious, 3 Minor
Flight Conducted Under:	Part 135: Air taxi & commuter - Non-scheduled - Sightseeing

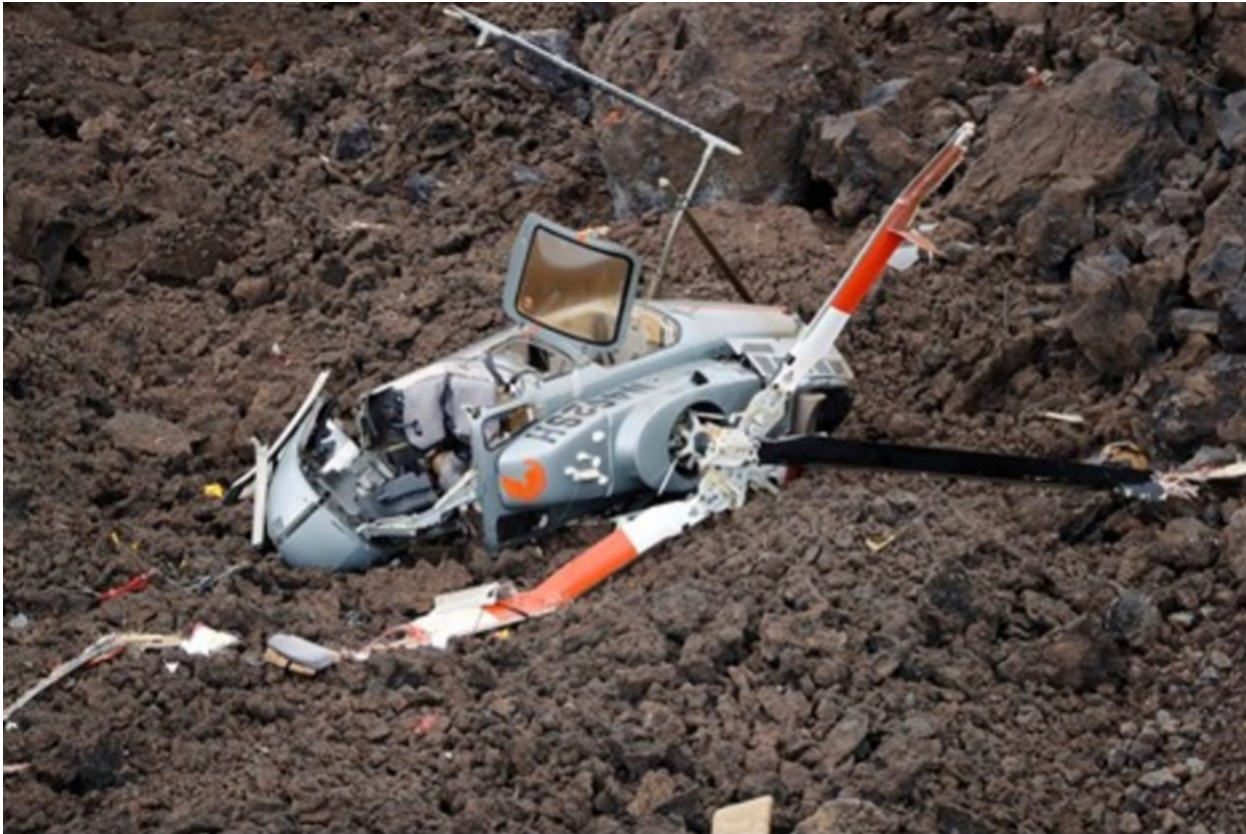
The pilot stated that the first part of the flight was normal. About 35 minutes into the flight, at an altitude of 1,500 ft agl and an airspeed of 130 knots, the helicopter experienced a violent upset, followed by an uncontrolled spin (yaw) to the right. A passenger, seated in the aft-left forward-facing seat, reported that as the helicopter continued to spin she observed something fall off the helicopter; however, she was not able to identify the specific part. The pilot communicated two mayday calls and attempted to recover helicopter control as it continued to spin uncontrollably and rapidly descend. The helicopter subsequently impacted a lava field and came to rest on its left side (see figure 1).

Figure 1. Main wreckage in a lava field.

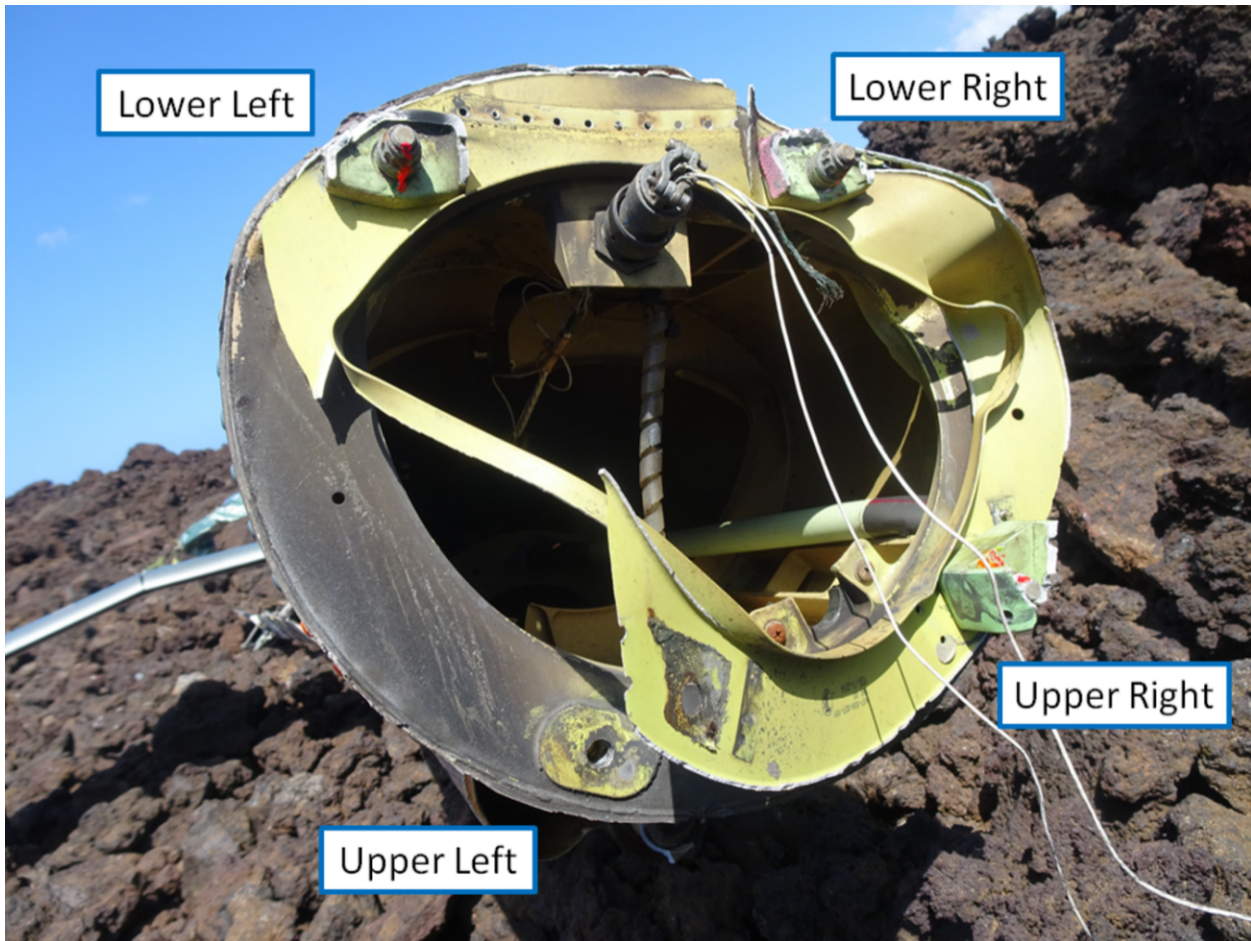
A National Transportation Safety Board (NTSB) examination of the accident site revealed the tail boom came to rest about 762 ft northeast of the main wreckage, which consisted of the fuselage, engine, and main rotor system. The tail boom separated from the aft fuselage at the tail boom attach point (see figures 2 and 3). The upper-left attachment fitting fastener was not present and the lower-left attachment fitting was fractured and displayed fatigue signatures. The fasteners for the lower-left, lower-right, and upper-right attachment fittings were present.

Figure 2. Tail boom at accident site with the four attachment fittings annotated.

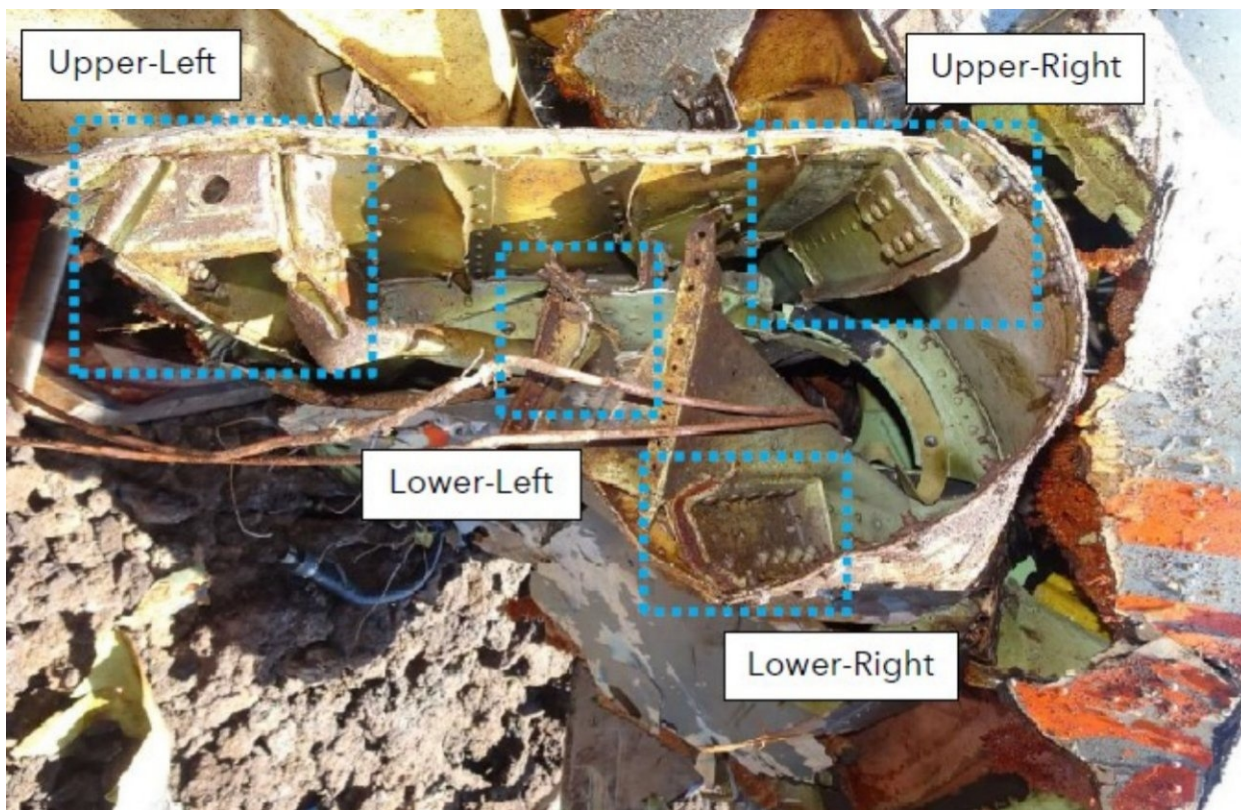
Figure 3. Aft fuselage at the accident site with the four longeron locations annotated.

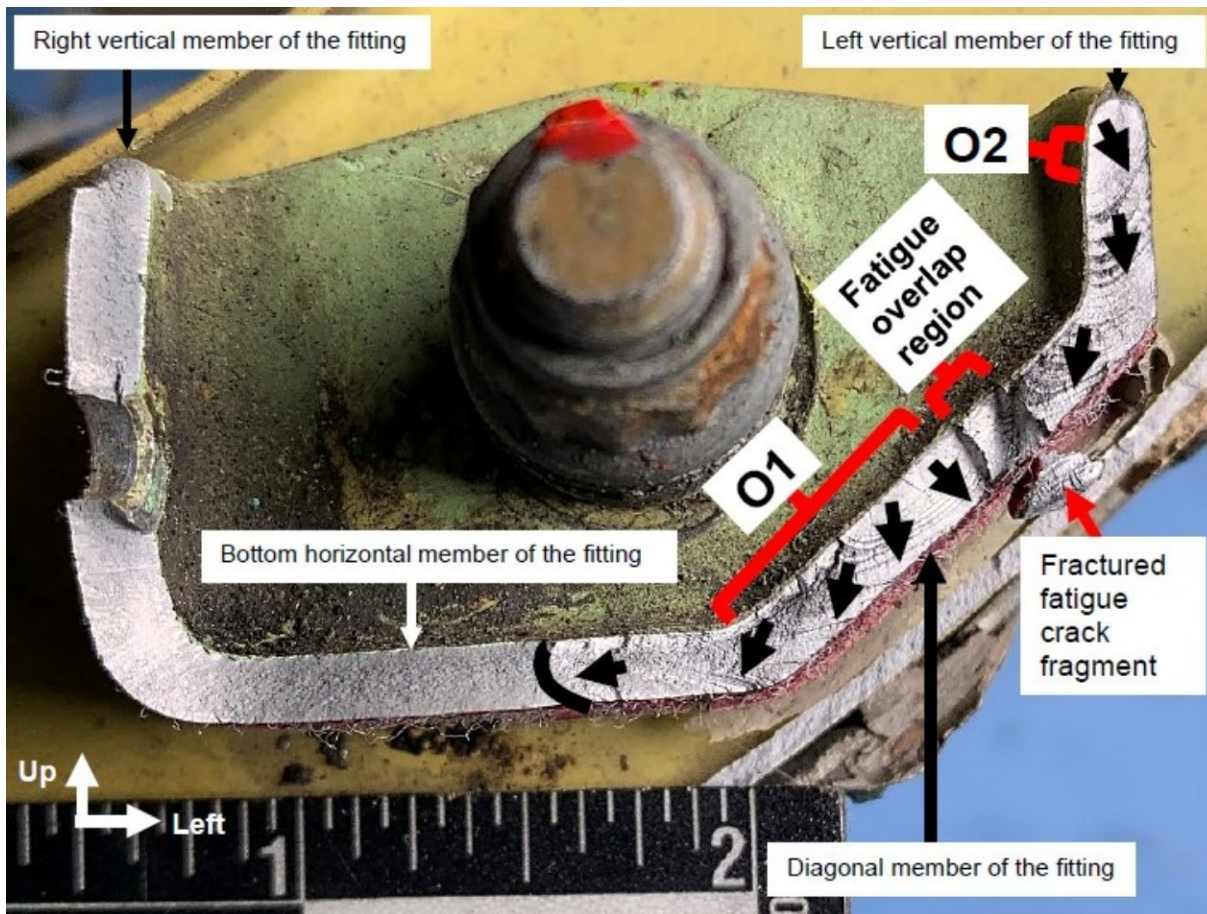
Examination of the lower-left fitting revealed the fracture face contained evidence of crack arrest marks typical of fatigue cracking that emanated from two separate areas, identified as O1 and O2 (see figure 4). Scanning electron microscope examination revealed that fatigue crack O1 emanated from multiple origins at the outer surface at an area that was located slightly forward of the inner transition radius of the diagonal wall member portion of the fitting. The fatigue origin contained no evidence of pitting corrosion. Fatigue propagation was down and through the wall then extended to the right of the fitting. The 1-inch fatigue crack contained alternating fatigue crack and overstress features.

Figure 4. Fractured lower left fitting showing fatigue cracking indicated by brackets "O1" and "O2".

Fatigue crack O2 emanated from a corrosion pit at the outer surface in an area slightly forward of the inner transition radius near the upper right end of the fitting. The fatigue crack propagated through the wall and then extended down where it intersected the left edge of fatigue crack O1. The 0.75-inch fatigue crack region contained alternating fatigue crack and overstress features. The bolt hole showed evidence of severe spiral gouge marks and fine spiral scratches. The spiral gouge marks did not extend all around the bore.
