## **Maryland Department of Environment**

Site Name:	Back River WWTP	
Facility Address:	8201 Eastern Ave, Baltimore, MD 21224	
County:	Baltimore County

Permit / Approval Numbers: 15DP0581 NPDES Numbers: MD0021555 Inspection Reason: Follow-up (Non-Compliance) Site Status: Active Compliance Status: Noncompliance Site Condition: Noncompliance Recommended Action: Additional Investigation Required Evidence Collected: Photos or Videos Taken, Visual Observation Delivery Method: Email Weather:

#### **Inspection Findings:**

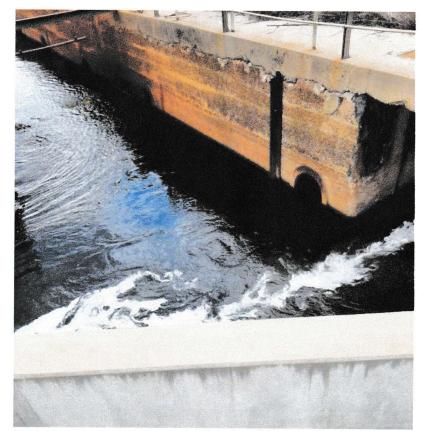
Next, I checked the wastewater traveling in the channels from the PSTs to the activated sludge plants. This wastewater was a dark grey color indicating a high concentration of solids in the waste stream. This is similar to my finding on 3/22/22. See pictures below:

Turbid dark grey wastewater flowing from the PST primary treatment to the biological reactors 3/26/22

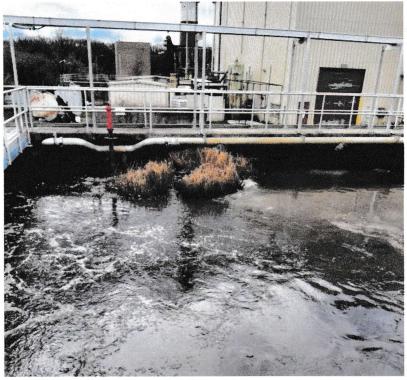
- 1. Some of the mixers in the A pass have vegetation growing on the blades which is hindering mixing capabilities. See picture below:
- 2. There is a heavy accumulation of solids with vegetation growing at the end of the reactor before going to the clarifiers. See pictures below:
- 3. The mixed liquor concentration (MLSS) in each reactor are ranging from 3190 6,500. Ideally the MLSS should be maintained approximately 3,000. The facility's target is between 2,600 2,800, however there is a wide range depending on the reactor. According to the plant engineer, Mr. Dan Latova due to the number of solids in the system they cannot meet that goal.

3/26/22 Vegetation growing in solids accumulated in one of the reactors

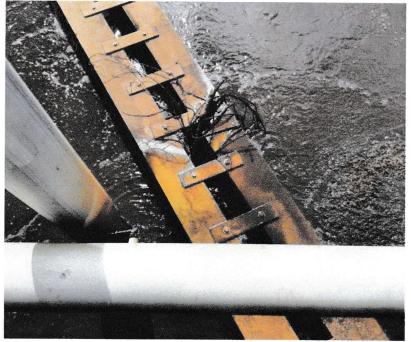
3/26/22 vegetation growing in reactor

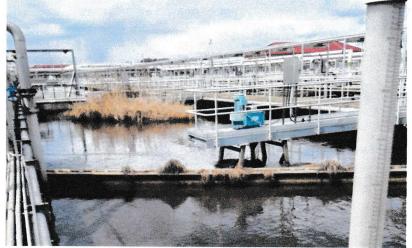
Vegetation growing in the reactor 3/26/22

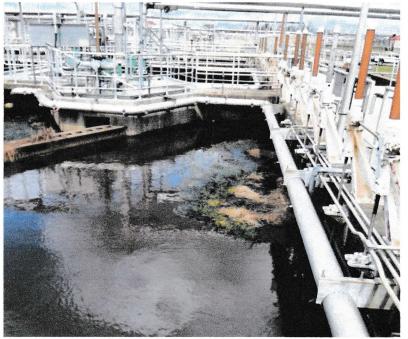
Solid's accumulation in the one of the reactors 3/26/22

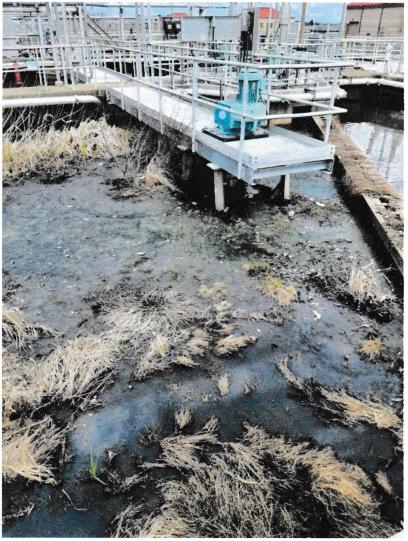
Mixer unable to turn properly due to solids in the reactor 3/26/22

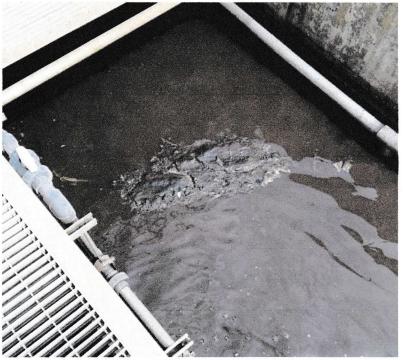
Floating solids in one of the reactors 3/26/22

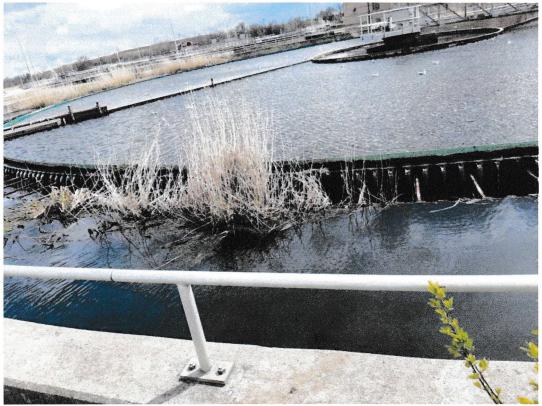
After inspecting the reactors, I inspected the secondary clarifiers. During an inspection of the secondary clarifiers, I found conditions similar to what I found during the March 22 inspection. There were problems with maintenance that inhibited operations and ultimately performance of the clarifiers. There was evidence of algae growth within the clarifiers. There was an accumulation of solids within in the clarifiers and floating solids and scum in the center well. The conditions of the clarifiers were the same as I observed during the previous inspection. The reed grasses and other vegetation remain in the clarifiers causing operational problems. Pictures below show concerns over the operation of the secondary clarifiers.

3/26/22 Secondary clarifier- vegetation and solids clogging the system and short-circuiting of the weirs.

- 4. Significant algal and vegetation are still present on the weirs of the secondary clarifiers. This has caused the short circuiting of the system and likely negatively impacts TSS concentration in the Plant's treatment train wastewater.
- 5. Significant amounts of solids are still present in the secondary clarifiers. This accumulation is decreasing the quality of the Plant's final effluent.
- 6. A significant amount of reed grasses and other vegetation are established in the secondary clarifiers. This is preventing the proper functioning of these clarifiers
- 7. Significant amounts of vegetation (*e.g.*, reed grasses) have grown and are established in the biological reactors and on the mixers in the reactors. This is preventing the proper functioning of these reactors.

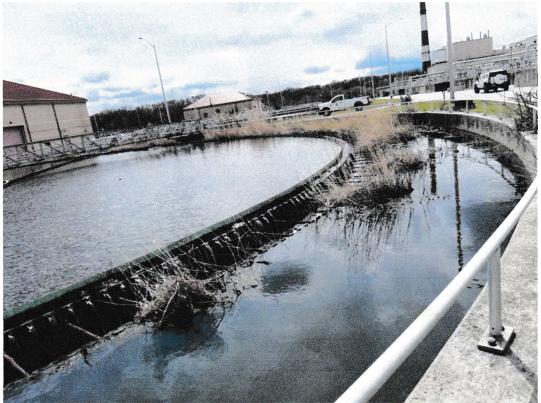
3/26/22 Secondary clarifier

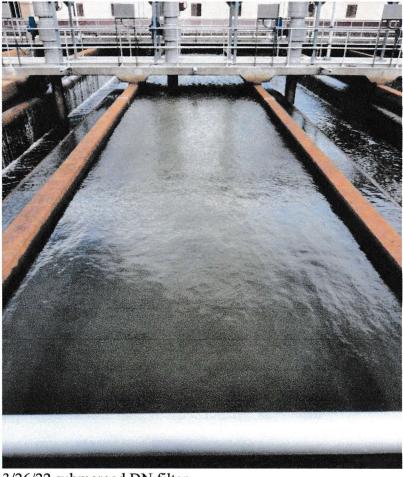
From the secondary clarifiers I traveled to the denitrification filter building. During this inspection, I found conditions similar to what I found during the last two inspections. Many of the filters were not functioning as designed. Quads #1, #2 and #4 were all submerged under water due to clogging during my last inspection. This condition has improved and not all of the filters are submerged as observed during the 3/22/22 inspection. However, some of the filters were submerged and not functioning as designed. The control stats show that 40 of the 52 are functioning and many of the filters had a floating layer of scum as described during the 3/22/22 inspection.

### 3/26/22 submerged DN filter

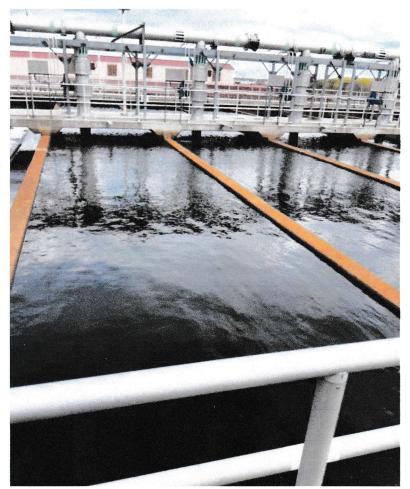
Submerged DN filters 3/26/22

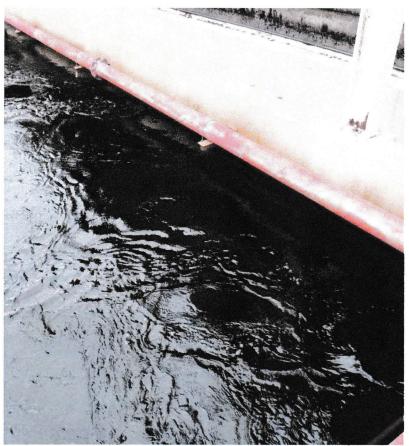
Next, I inspected the effluent from the DN filters entering the sand filters. The water appeared dark grey. See picture below. I continued this inspection with an inspection of the sand filters. The facility has 48 sand filters and according to Mr. Turner, 15 of the 48 are functioning. During an inspection of the sand filters, the traveling bridges appeared to be not functioning.

Effluent from the DN filters going to the sand filters. 3/26/22

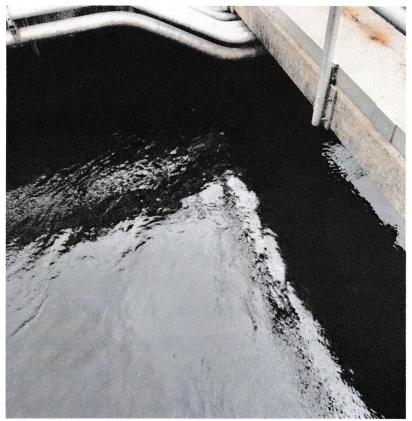
The effluent from the sand filters flows to the chlorine contact chamber. The effluent appeared dark grey. See picture below:

Effluent from the sand filters 3/26/22 has a dark grey color.

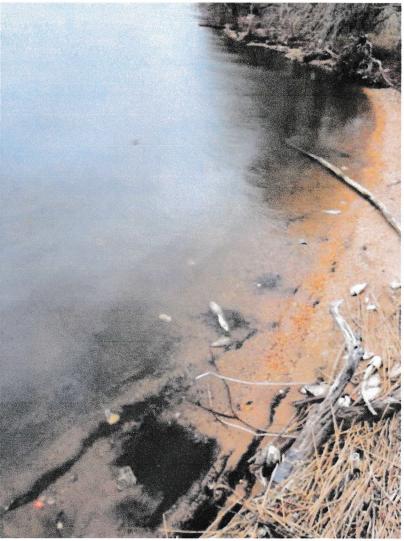
3/26/22 Shoreline near discharge point shows heavy dark sediments along the shoreline.

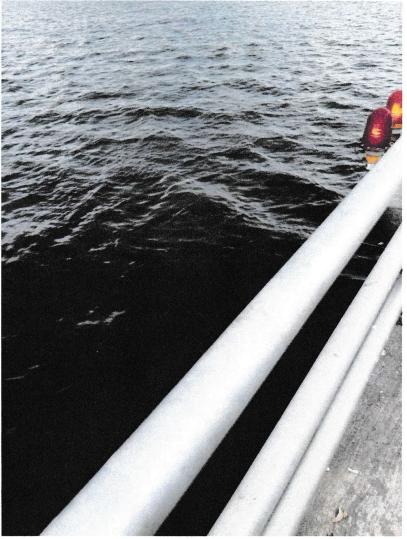
Back River above the submerged discharge point to the river at the end of the pier 3/26/22
