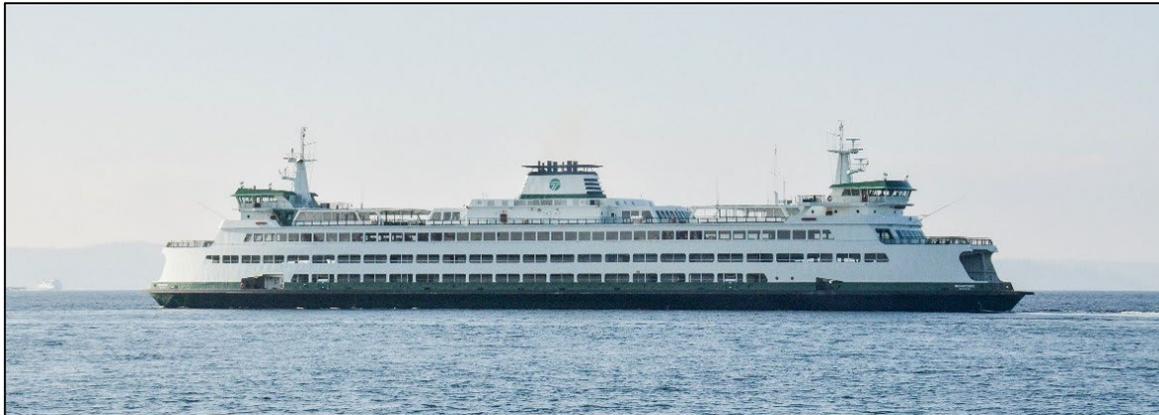
Figure 1. *Wenatchee* under way before the casualty. (Source: Washington State Ferries [WSF])

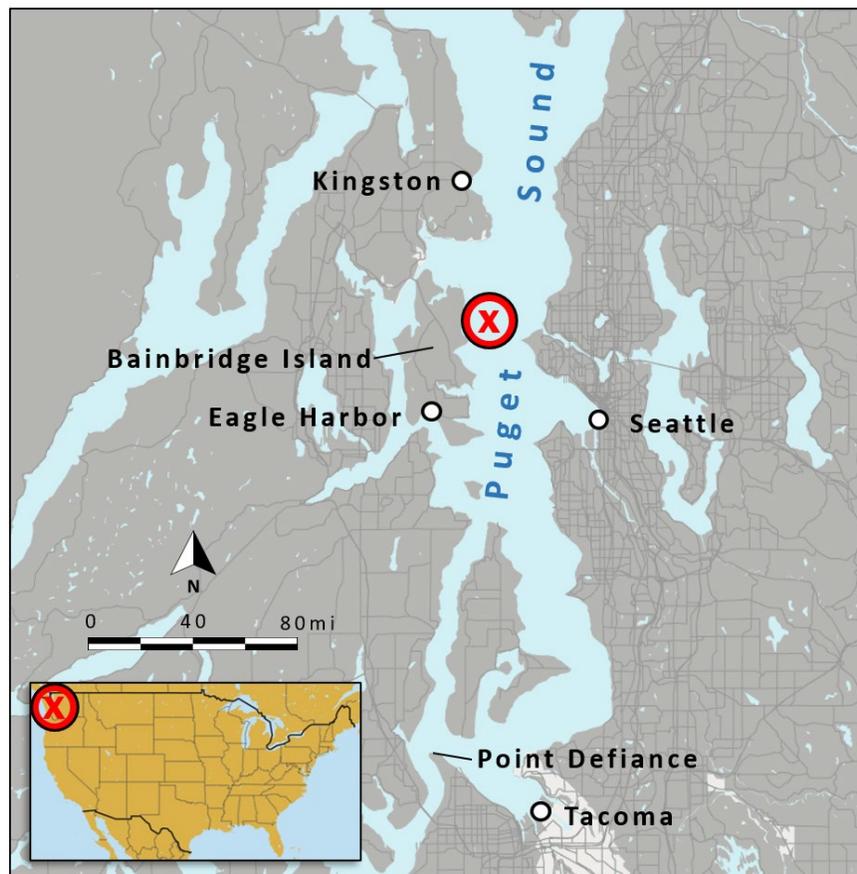
Figure 2. Area where the no. 3 main engine failed aboard the *Wenatchee*, as indicated by the red X. (Background source: Google Maps)

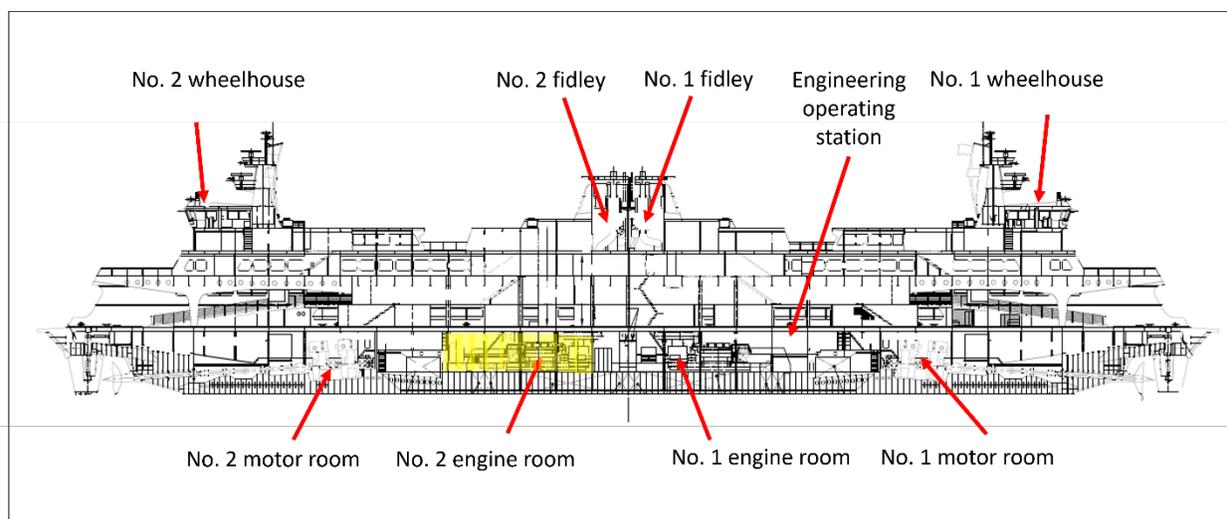
Figure 3. Profile drawing of *Wenatchee*. Yellow highlight identifies the location of no. 2 engine room, where the no. 3 main engine failure occurred. (Source: WSF, annotated by NTSB)

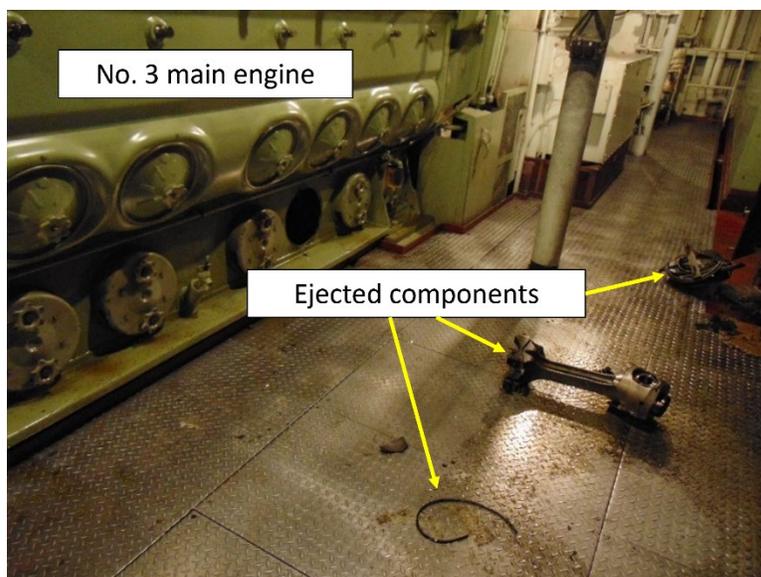
Figure 5. Ejected components from the no. 3 main engine. (Source: Coast Guard)

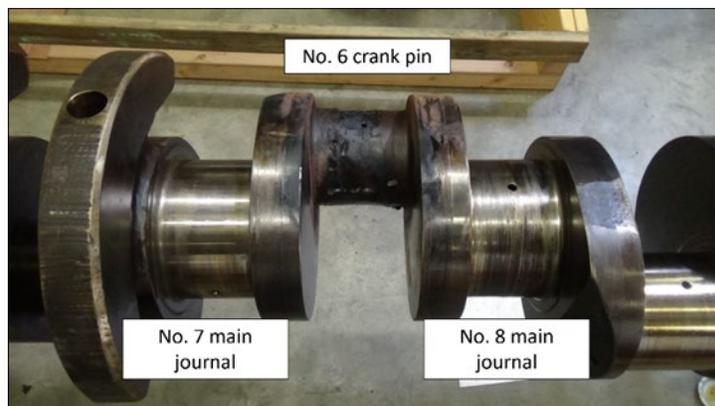
Figure 6. Damaged crankshaft from no. 3 main engine. (Source: Dynamark Engineering)

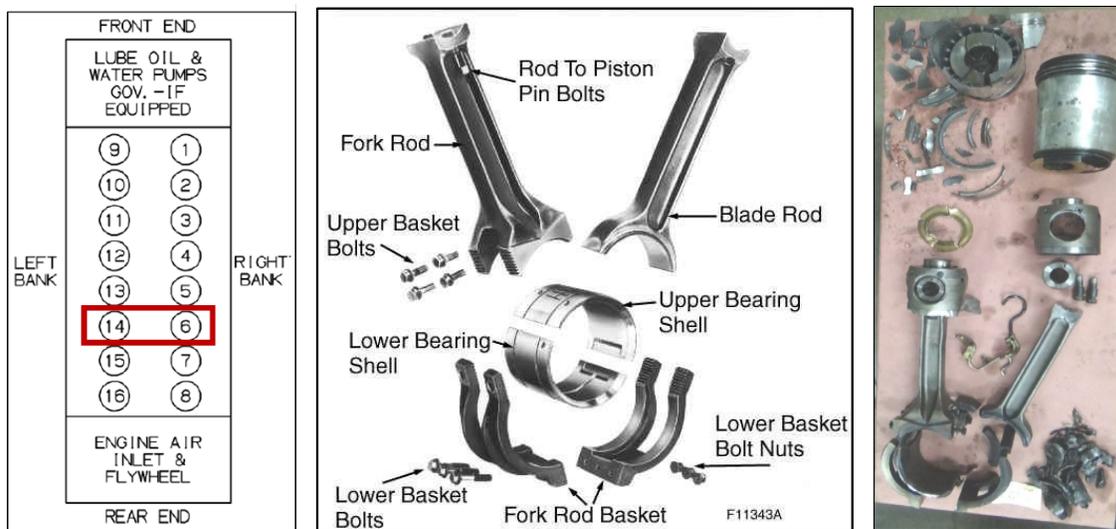
Figure 7. Left: EMD 710 cylinder arrangement showing the affected area in red. Center: EMD 710 connecting rod arrangement. Right: Damaged components recovered from no. 3 main engine no. 6 and 14 cylinders. (Source: Dynamark Engineering)

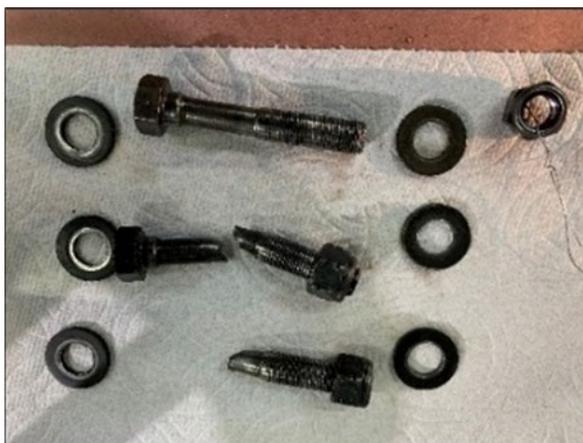
Figure 8. Damaged lower basket bolts, washers, and nuts from no. 3 main engine's nos. 6 and 14 connecting rod and piston pair. (Source: WSF)
