## **Evaluation of the Tailings Dam, Cyanide Use and Water Consumption at the Proposed Volta Grande Gold Project, Pará, Northern Brazil**

Steven H. Emerman, Ph.D., Malach Consulting, LLC, 785 N 200 W, Spanish Fork, Utah 84660, USA, Tel: 1-801-921-1228, E-mail: SHEmerman@gmail.com

Report written at the request of Amazon Watch, submitted June 1, 2020

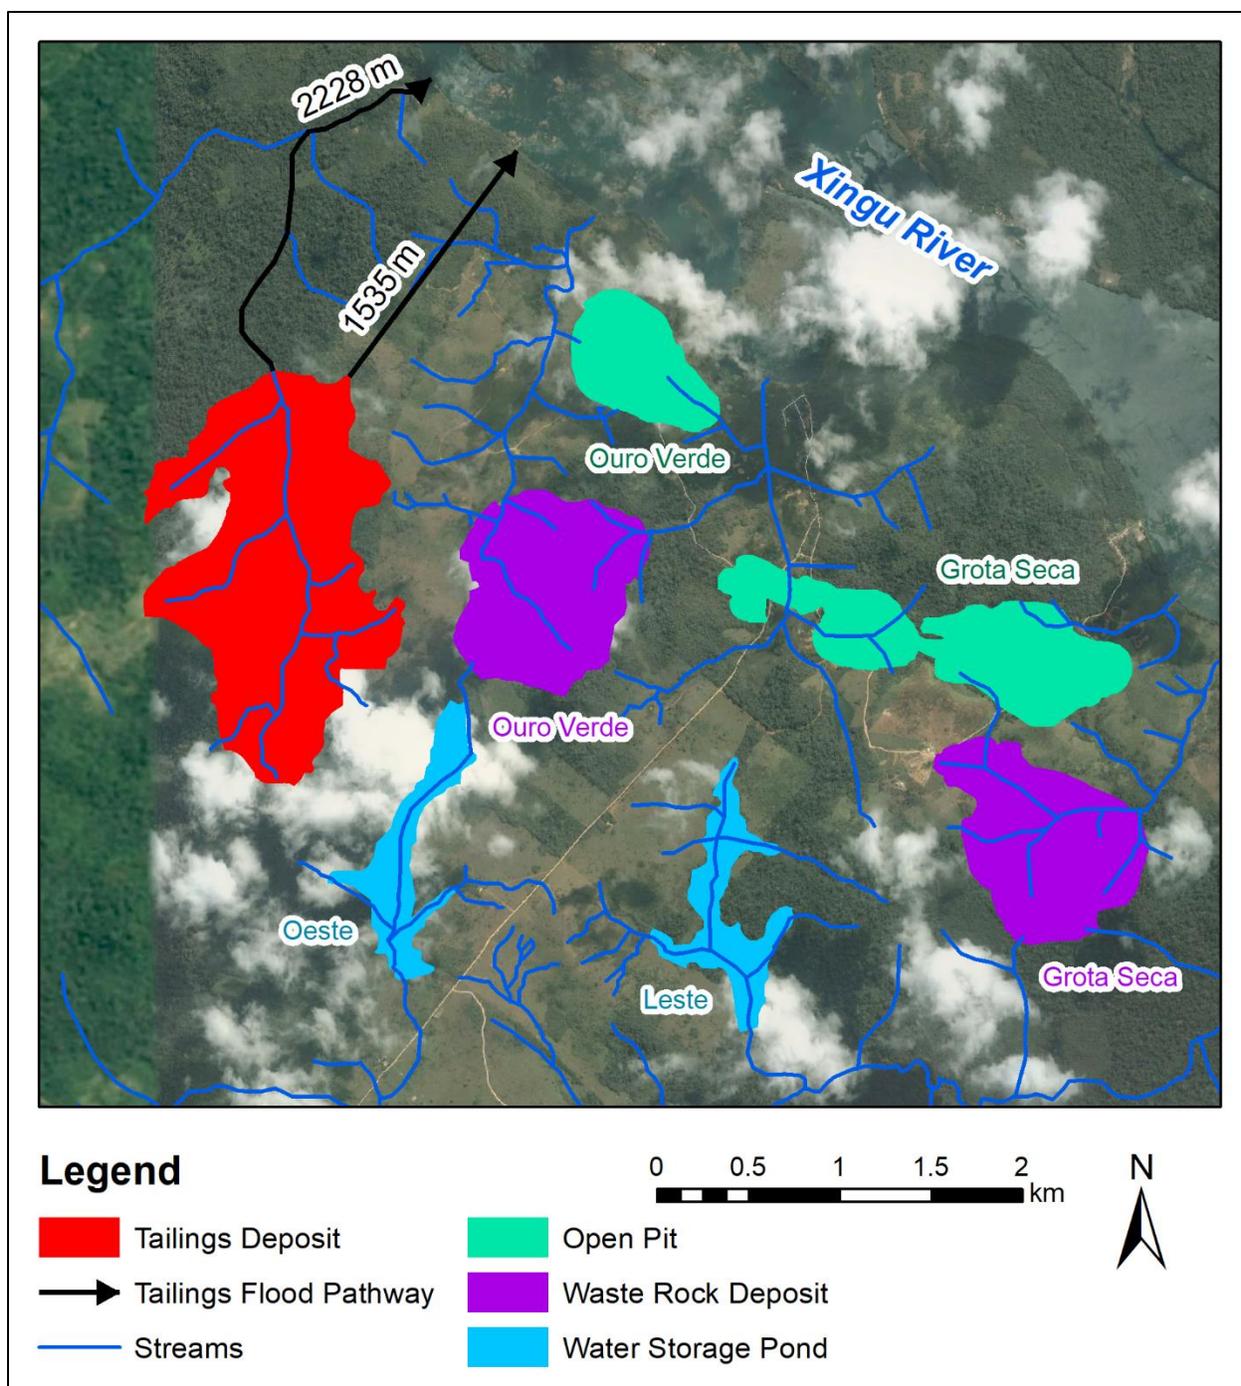
**Figure 3.** The infrastructure for the Volta Grande Project would include two open pits, two water storage ponds, two waste rock deposits, and a tailings deposit. Although the tailings deposit would be 1535 meters from the Xingu River, a tailings dam failure would probably result in the travel of tailings along the course of a stream channel for 2228 meters to the Xingu River. Based on an observed minimum tailings flood velocity of 20 kilometers per hour, the tailings would reach the Xingu River in less than 7 minutes. By contrast, Brandt Meio Ambiente (2016a) estimated that the tailings flood would reach the Xingu River in 97 minutes (corresponding to a tailings flood velocity of 1.4 kilometers per hour). Mine infrastructure and streams traced from Brandt Meio Ambiente (2016a, 2016c).

Belo Sun Mineração, a wholly-owned subsidiary of the Canadian company Belo Sun Mining, has proposed the construction of the Volta Grande Gold Project along the banks of the Xingu River, a major tributary of the Amazon River in the state of Pará in northern Brazil (see Figs. 1-2). The proposed gold mine would operate for 12 years and would use cyanide to extract gold from 3.5 million metric tons of ore per year with an average grade of 1.47 grams of gold per metric ton of ore (Brandt Meio Ambiente, 2016a). The mine would be located about 15 kilometers south of the Belo Monte dam (see Fig. 2), which was completed in November 2019 and which diverts 80% of the flow of the Xingu River for generation of hydroelectric power (Higgins, 2020). The proposed mine site would be about 12 kilometers southwest and about 16 kilometers west of the indigenous lands of the Paquiçamba and the Arara de Volta Grande do Xingu, respectively (see Fig. 2). The gold ore would be mined from two open pits, Grota Seca and Ouro Verde (see Fig. 3), each of which would be about 220 meters deep. The mining operation would not take water directly from the Xingu River, but would capture water from precipitation, surface runoff and tributaries of the Xingu River in two water storage ponds, Leste and Oeste, and in the tailings deposit (see Fig. 3; Brandt Meio Ambiente, 2016a).

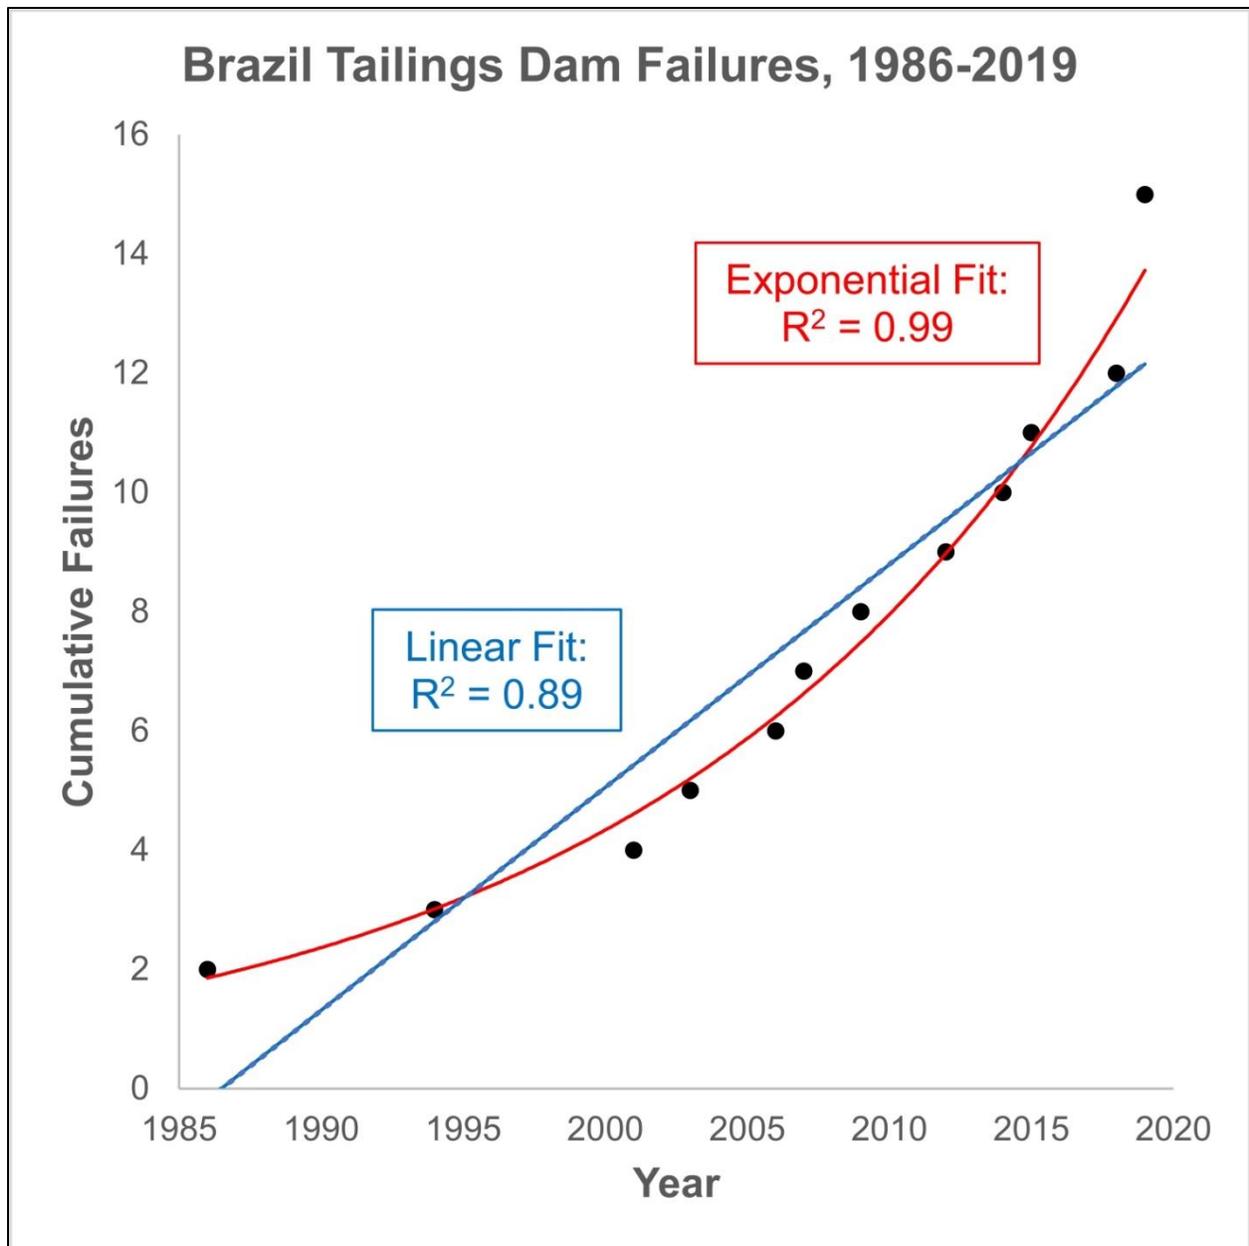
**Figure 4.** Brazil experienced 15 tailings dam failures from 1986 to 2019 (see Table 1). Based on 769 tailings dams in Brazil as of February 2019 (Agência Nacional de Mineração, 2019a), the annual failure rate has been 0.06%. The calculated failure rate must be an underestimate because not all current tailings dams have been in existence since 1986. The annual tailings dam failure rate in Brazil is comparable to the global annual failure rate of 0.06-0.14% (Davies, 2002) and the annual failure rate in British Columbia of 0.17% (Independent Expert Engineering Investigation and Review Panel, 2015), but is significantly greater than the global annual failure rate of 0.01% for water-retention dams (Davies, 2002). The tailings dam failure rate in Brazil has been increasing exponentially with three failures occurring in 2019 alone (see Table 1).

It is most relevant that Brazil experienced 15 tailings dam failures from 1986 to 2019 (see Table 1; Fig. 4). Based on 769 tailings dams in Brazil as of February 2019 (Agência Nacional de Mineração [National Mining Agency], 2019a), the annual failure rate has been 0.06%. The calculated failure rate must be an underestimate because not all current tailings dams have been in existence since 1986. The annual tailings dam failure rate in Brazil is comparable to the global annual failure rate of 0.06-0.14% (Davies, 2002) and the annual failure rate in British Columbia of 0.17% (Independent Expert Engineering Investigation and Review Panel, 2015), but is significantly greater than the global annual failure rate of 0.01% for water-retention dams (Davies, 2002). It is alarming that the safety record of tailings dams in Brazil is not improving, but is becoming worse. In fact, the tailings dam failure rate in Brazil has been increasing exponentially with three failures occurring in 2019 alone (see Table 1 and Fig. 4).

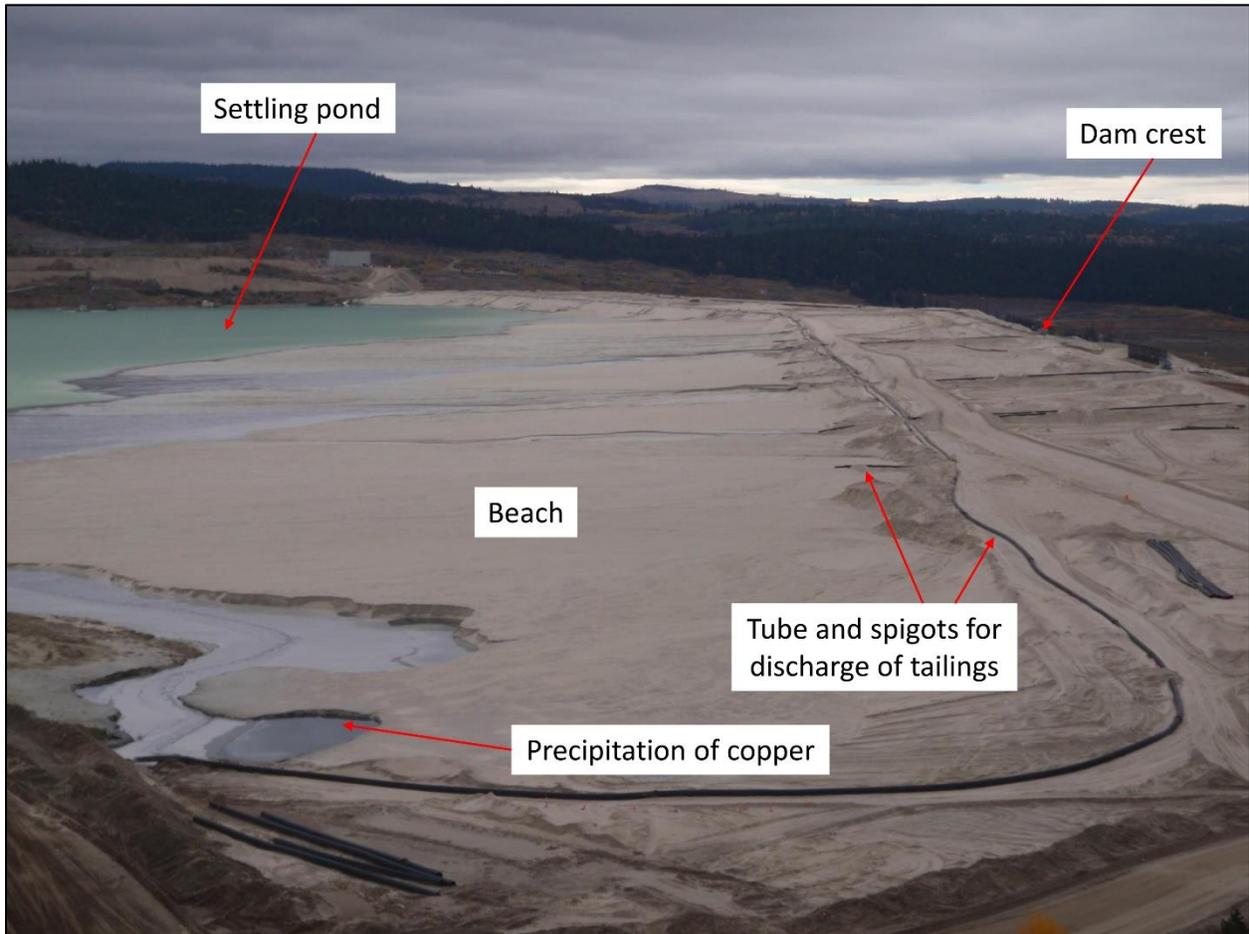
**Figure 5.** At the tailings storage facility of the Highland Valley Copper mine in British Columbia, wet tailings are discharged in the upstream direction from a tube and spigots along the crest of the dam. Larger particles (sands) are deposited near the dam to form a beach. Smaller particles (slimes) are transported farther from the dam to form a settling pond. The precipitation of copper in the tailings reservoir indicates the incomplete extraction of copper from the ore. Photo taken by the author on September 27, 2018.

management facilities. Normally, a mixture of tailings and water is discharged into the tailings pond from the crest of the dam through spigots that connect to a pipe that comes from the ore processing plant (see Fig. 5). The larger sands settle closer to the dam to form a beach. The smaller slimes and water travel farther from the dam to form a settling pond where the slimes slowly settle out of suspension. It should be noted that the beach is essential for preventing the pond from reaching the crest of the dam.

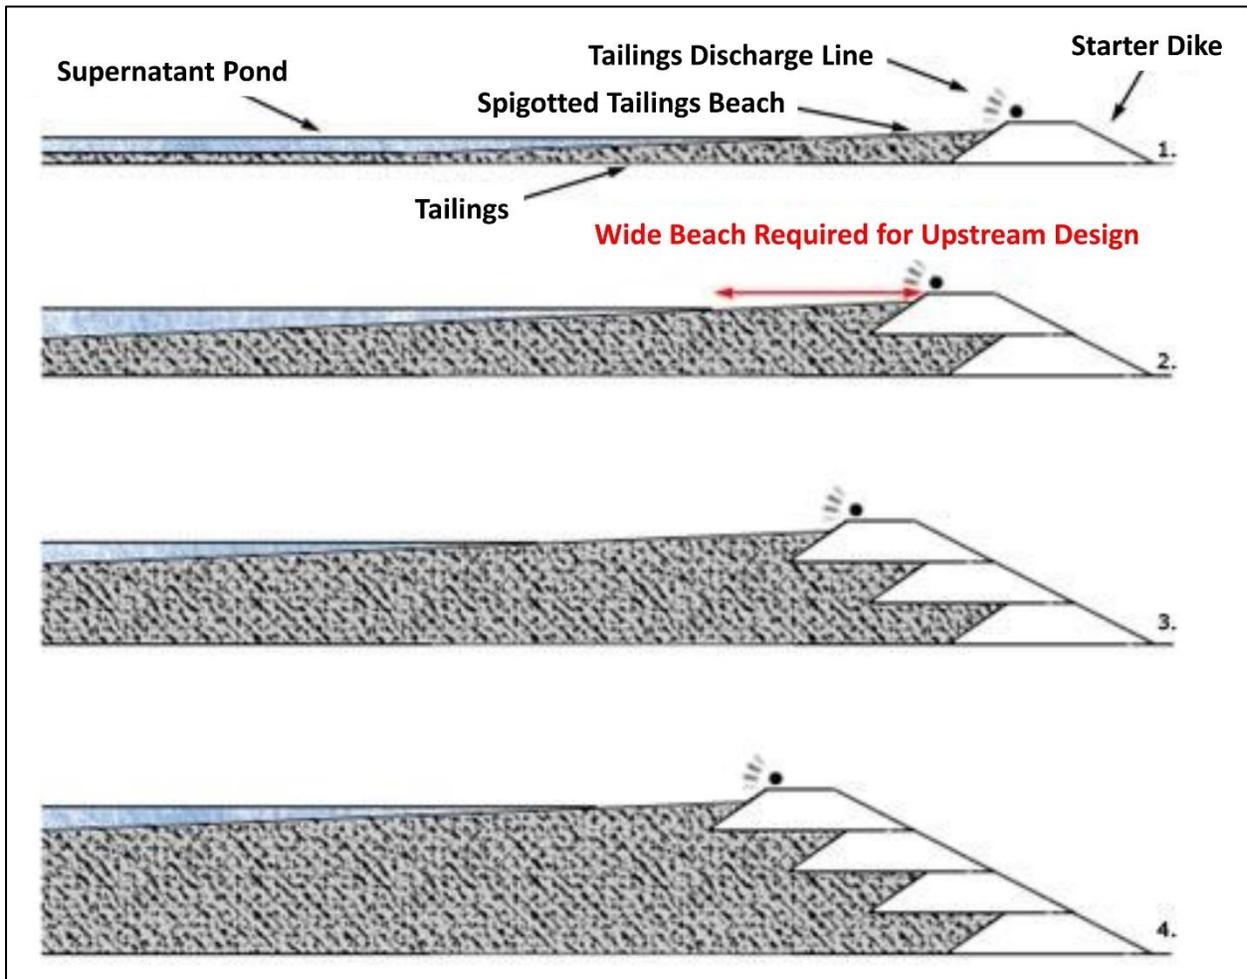
**Figure 6a.** In the upstream construction method, successive dikes are built in the upstream direction as the level of stored tailings increases. Dikes can be constructed with mine waste rock, natural soil, natural rock fill, or the coarser fraction of tailings (with proper compaction). The advantage of the method is its low cost because very little material is required for the construction of the dam. The disadvantage is that the dam is susceptible to failure due to seismic or static liquefaction because the non-compacted wet tailings are below the dam. For this reason, the upstream construction method is illegal in Brazil, Chile, Ecuador and Peru. Dams constructed by this method are also susceptible to flood failure when the beach is too narrow due to an insufficient amount of sand in the discharged tailings or excessive water in the settling pond. Figure from TailPro Consulting (2020).

Each of the three common methods of building tailings dams (upstream, downstream and centerline) begins with a starter dike, which is constructed from natural soil, rock fill, mine waste rock or the tailings from an earlier episode of ore processing (see Figs. 6a-c). In the upstream construction method, successive dikes are built in the upstream direction as the level of stored tailings increases. As mentioned earlier, it is most common to build successive dikes from waste rock or the coarser fraction of tailings (with appropriate compaction). The advantage of the method is its low cost since very little material is required for the construction of the dam (see Fig. 6a). The downstream construction method is the most expensive since it requires the most construction material (compare Figs. 6a and 6b). In this method, successive dikes are constructed

(see Fig. 6a). Thus, even if the dam temporarily maintains its structural integrity while the underlying tailings liquefy, the dam could fail by either falling into or sliding over the liquefied tailings. For this reason, the upstream construction method is illegal in Chile (Ministerio de Minería [Ministry of Mining], 2007), Ecuador (Valencia, 2019) and Peru (Sistema Nacional de Información Ambiental [National System of Environmental Information], 2014) due to their high potential for strong earthquakes. The upstream construction method is even banned in Brazil (Agência Nacional de Mineração [National Mining Agency], 2019b; Assembleia Legislativa de Minas Gerais [Legislative Assembly of Minas Gerais], 2019), and effectively banned in the province of Ontario, Canada (MacDonald et al., 2019), where the potential for large earthquakes is much lower. Dams constructed using the centerline method retain some vulnerability to failure during liquefaction because there are still some uncompacted tailings underneath the dikes (see Fig. 6c). On the other hand, a tailings dam constructed using the downstream method could survive the complete liquefaction of the tailings stored behind the dam (see Fig. 6b). Of course, proper design and construction are still needed to prevent liquefaction of the dam itself even when the downstream method is used.

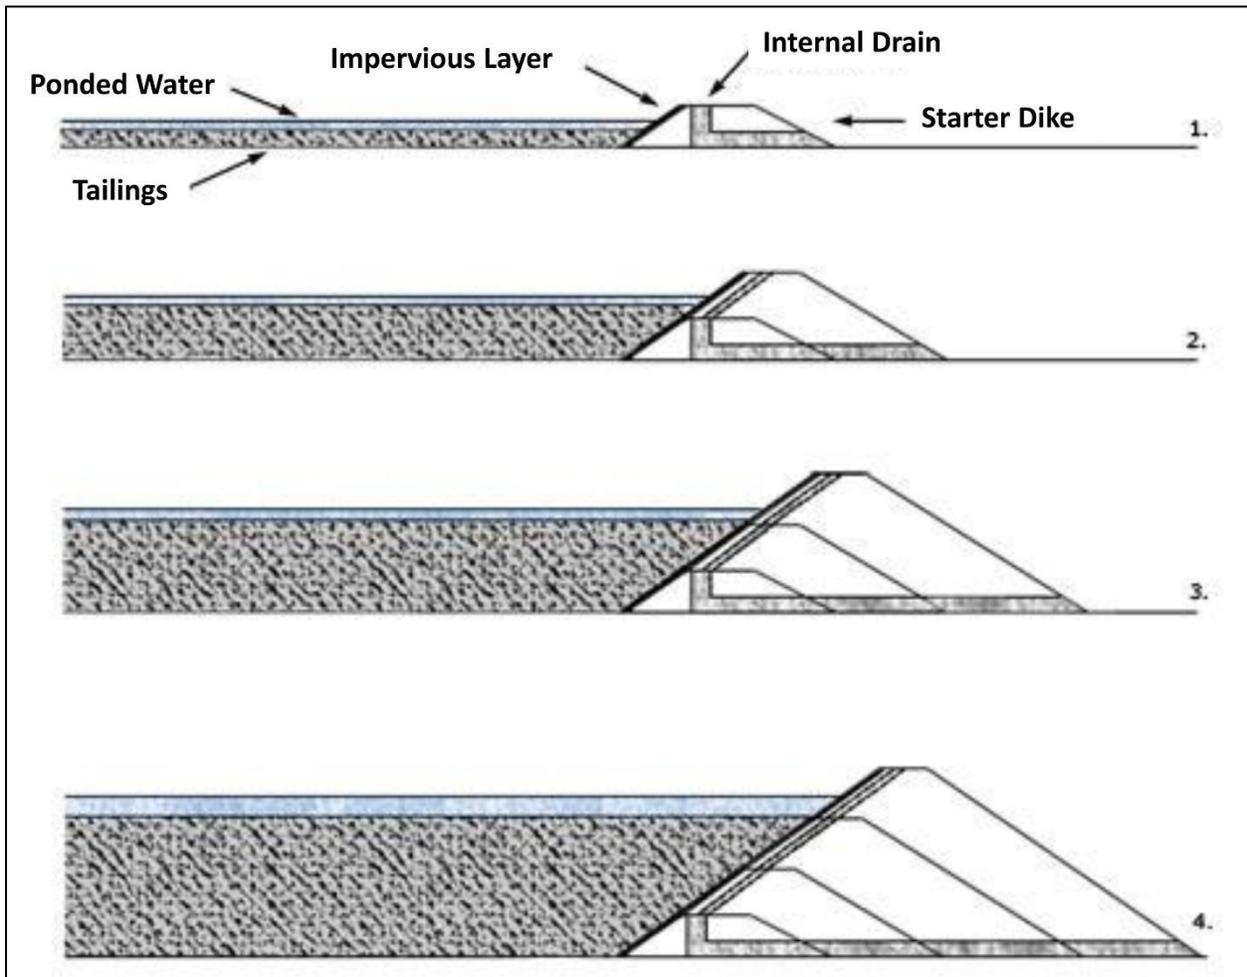
**Figure 6b.** In the downstream construction method, successive dikes are constructed in the downstream direction as the level of stored tailings increases. Dikes can be constructed from mine waste rock, natural soil, natural rock fill, or the coarser fraction of tailings (with proper compaction). The resistance to seismic and static liquefaction is high because there are no uncompacted tailings below the dam. The disadvantage of the method is its high cost due to the amount of material required to build the dikes (compare the dike volumes in Figs. 6a and 6b). Figure from TailPro Consulting (2020).

The tailings dam for the Volta Grande Project would be constructed in two stages using the downstream construction method (see Figs. 6b and 8). The starter dike would be constructed out of compacted soil from the project site to a height of 26.5 meters. The final dike would be constructed out of compacted soil on the upstream side and mine waste rock on the downstream side to a final height of 44 meters (see Fig. 8). Before export to the tailings pond, the cyanide would be destroyed using sulfur dioxide and the tailings would be thickened to a solids content of 53% by weight. The tailings dam would have zero downstream discharge in that all seepage from the dam would be pumped back into the tailings pond (Brandt Meio Ambiente, 2016a; VOGBR, 2016a).

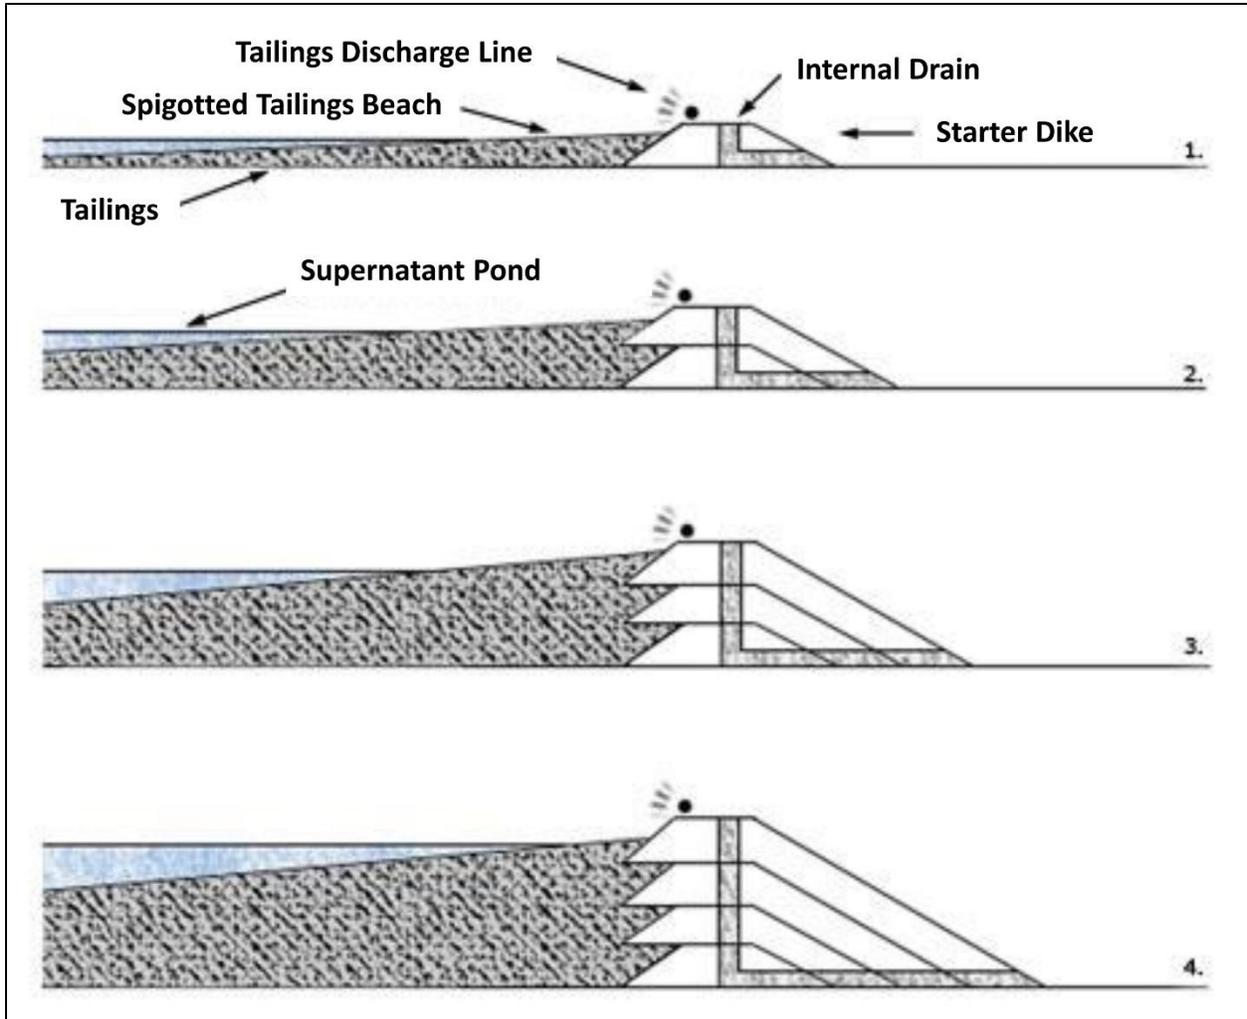
**Figure 6c.** In the centerline construction method, successive dikes are constructed by placing construction material on the beach and on the slope downstream of the previous dike. The central lines of the rises coincide as the dam is built upwards. Dikes can be constructed from mine waste rock, natural soil, natural rock fill, or the coarser fraction of tailings (with proper compaction). The centerline method is intermediate between the upstream and downstream methods (see Figs. 6a-b) in terms of cost and risk of failure. The resistance to seismic and static liquefaction is moderate because there are still some uncompacted tailings below the dikes. It is still necessary to maintain a suitable beach to avoid flooding the dam. Figure from TailPro Consulting (2020).

in the downstream direction as the level of stored tailings increases. The centerline construction method is a balance between the advantages and disadvantages of the downstream and upstream construction methods (compare Figs. 6a-c). In this method, successive dikes are constructed by placing construction material on the beach and on the slope downstream of the previous dike. The center lines of the raises coincide as the dam is built upwards (see Fig. 6c). The advantages and disadvantages of different types of construction in terms of their ability to resist catastrophic failures will be discussed after reviewing the common causes of failure of tailings dams.

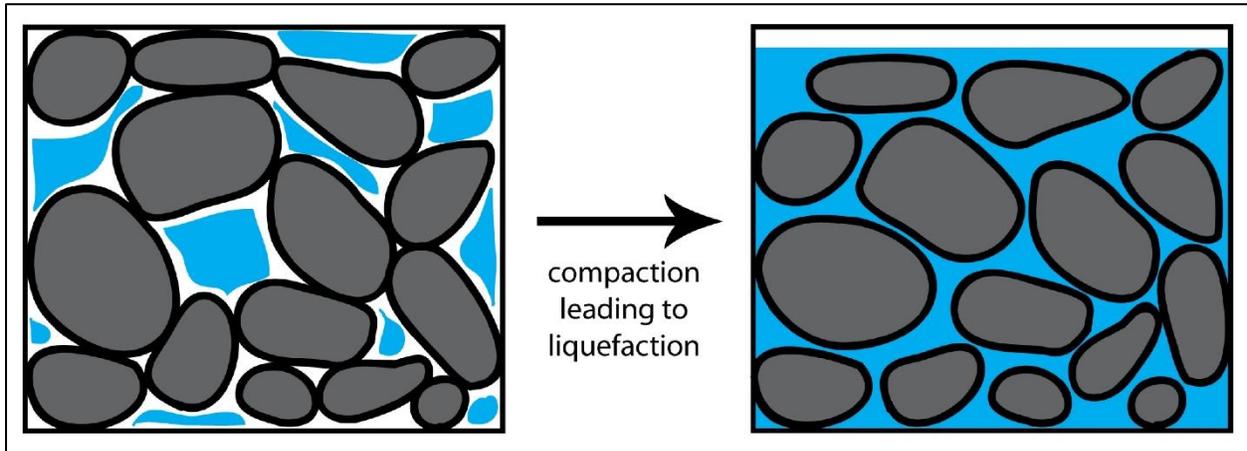
**Figure 7.** In the diagram on the left, although the solid particles are loosely packed and the pores are saturated, the particles touch each other, so that the load is supported by the particles (and partially by the water). In the diagram on the right, following an increase in load or a disturbance (such as an earthquake), the solids consolidate to a more densely-packed state. If the water cannot escape (due to low permeability or the speed of the disturbance), the water is compressed and the water pressure increases, so that the particles no longer touch each other. In this case, the water supports the entire load, so that the mass of particles and water behaves like a liquid. This phenomenon of liquefaction is promoted by saturated pores and loosely-packed particles. Tailing deposits are especially susceptible to liquefaction because the tailings are very loosely-packed due to the hydraulic discharge into the reservoir without compaction (see Fig. 5). Figure from DoITPoMS (2019).

Liquefaction is the phenomenon in which a porous medium (usually sands) loses all strength and behaves as if it were a liquid. On the left-hand side of Fig. 7, although the solid particles are loosely packed and the pores are saturated, the particles touch each other, so that the load is supported by the particles (and partially by the water). On the right-hand side of Fig. 7, following an increase in load or a disturbance (such as an earthquake), the solids could suddenly consolidate to a more densely-packed state. If the water cannot escape (due to low permeability or the speed of the disturbance), the water is compressed and the water pressure increases, so that

the particles no longer touch each other. In this case, the water supports the entire load, so that the mass of particles and water behaves like a liquid. This phenomenon of liquefaction is promoted by saturated pores and loosely-packed particles.

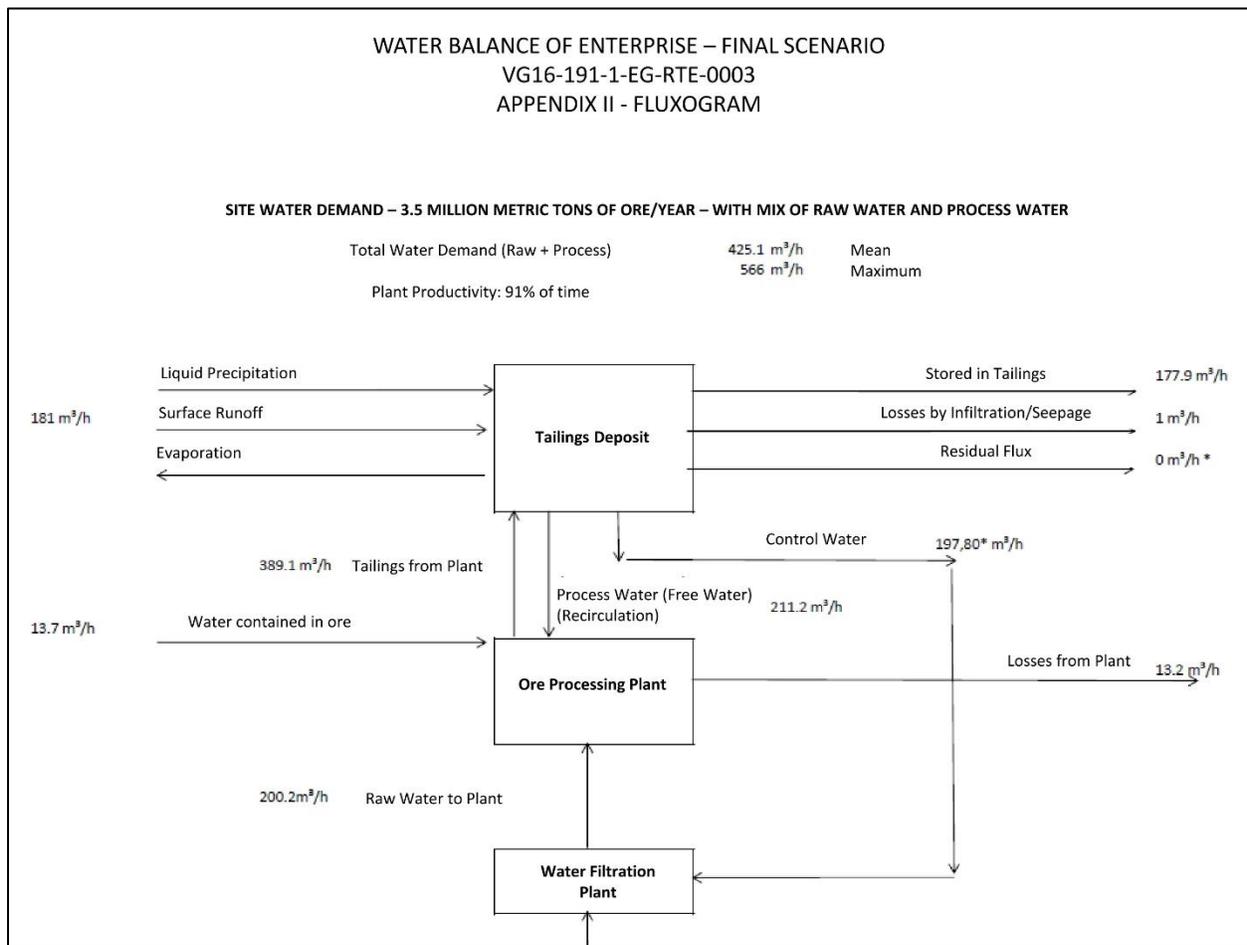
**Figure 10.** The mixture of tailings and water would be thickened to a 53% solids content before export to the tailings deposit. However, the addition of 181 cubic meters of water from the catchment for every 389.1 cubic meters of water from the ore processing plant would give the mixture of tailings and water an effective solids content of 43%, which is within the range for conventional tailings management with no thickening. The addition of catchment water to the tailings deposit is the opposite of the current practice of constructing diversion canals around the tailings deposit in order to prevent the entry of catchment water so as to reduce the water stored behind the tailings dam. Because of the use of cyanide in the ore processing plant, the recirculation of water from the tailings deposit has the potential to increase the concentrations of antimony, arsenic and mercury in the water with each passage through the ore processing plant. Portion of figure from VOGBR (2016b) overlain with English labels.

It has already been mentioned that the use of cyanide to extract gold from crushed ore also has the potential to dissolve arsenic, antimony, and mercury. Moreover, the processes that are used to remove the gold from the cyanide solution and to destroy the cyanide will not remove the toxic by-products antimony, arsenic and mercury from the spent cyanide leach. Since, according to the plan for the Volta Grande Project, the cyanide leach would be endlessly recycled between the ore processing plant and the tailings deposit with no intervening water treatment (see Fig. 10), the cyanide leach has the potential to become increasingly enriched in

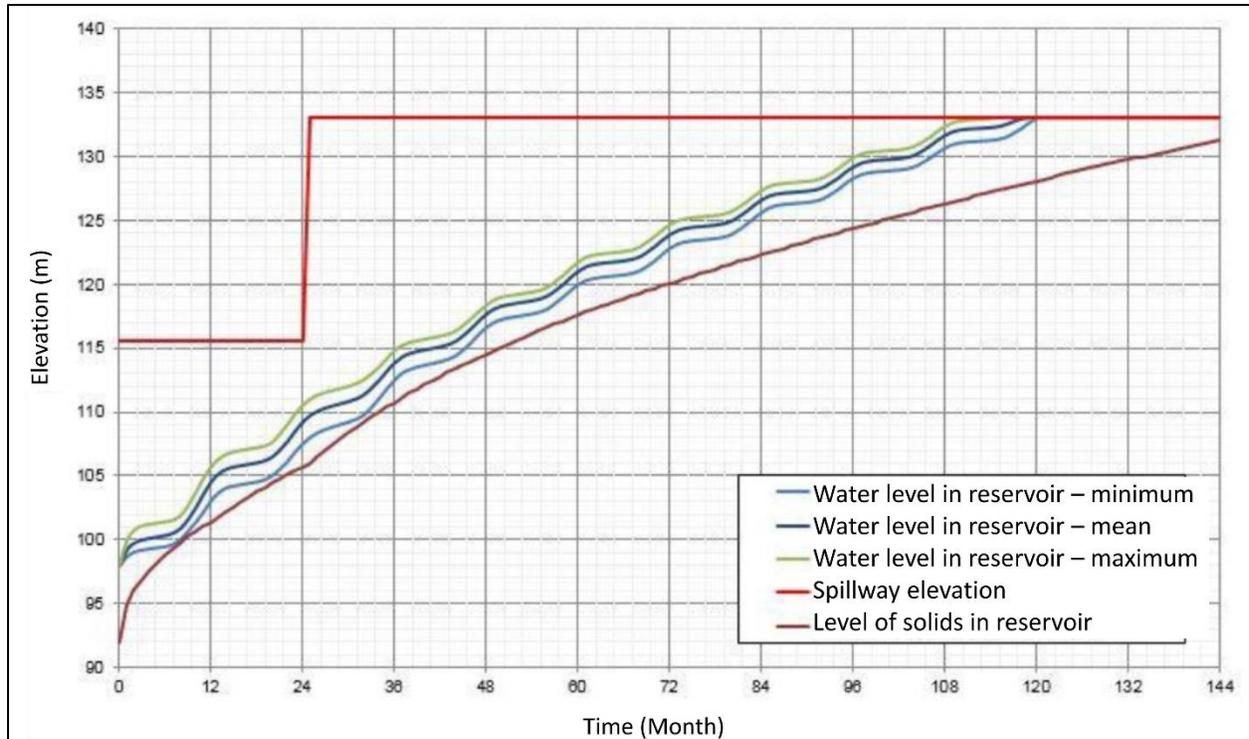
**Figure 11b.** The entry of catchment water into the tailings deposit and the lack of downstream discharge from the tailings dam would allow the tailings deposit to act as a reservoir of free water (water that is not stored in the pores between the tailings) for recycling into the ore processing plant (see Fig. 10). After 10 years of mining, the water level behind the tailings dam should be 7 meters above the level of the solid tailings (see Fig. 11a). The result is that the tailings will be completely saturated with water. This is opposite of the current practice of reducing the water content and lowering the water table within the tailings in order to reduce both the probability and the consequences of dam failure. Figure from VOGBR (2016b) overlain with English labels.

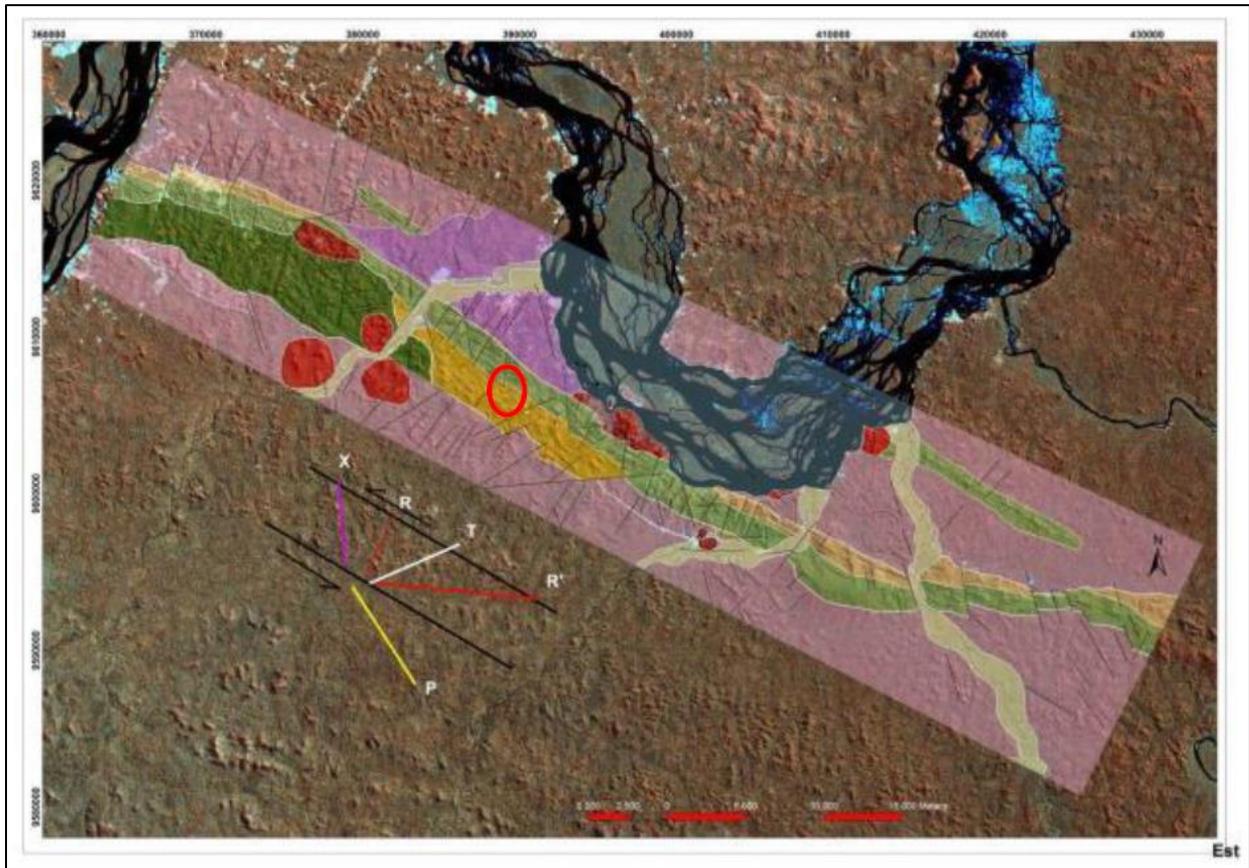
**Figure 13a.** A geological map superimposed onto a Landsat image shows possible faults with directions T, R, X, P and R' in the vicinity of the tailings deposit (red ellipse). (Compare with Fig. 2 for location). Although the figure was provided by VOGBR (2016a), there was no discussion of the ability of the faults to act as sources of seismicity that could impact the tailings dam. Figure from VOGBR (2016a).

It is most disturbing that the existing stability analyses were carried out only under static conditions and not under the condition of a design seismic acceleration. In fact, none of the documents of the 2016 EIS discuss a design earthquake or include any analysis of local or regional seismicity. This is surprising because the documents show maps of faults and fractures in the vicinity of the mining project site, including three possible faults intersecting at the exact site of the proposed tailings dam (see Figs. 13a-b; VOGBR, 2016a). However, these faults were discussed only in terms of their ability to transmit seepage of water from the tailings deposit, and not in terms of their ability to act as sources of seismicity.
